# Home Report

# Single Survey

<b>Property address</b>	59 Deyhill Macduff AB44 1PX
-------------------------	-----------------------------------

<b>Prepared by</b>	Shepherd Chartered Surveyors
--------------------	------------------------------

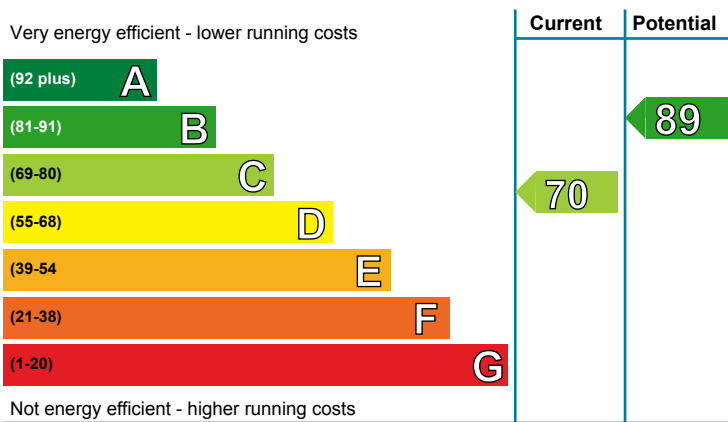
## Energy Efficiency Rating

This graph shows the current efficiency of your home, taking into account both energy efficiency and fuel costs. The higher this rating, the lower your fuel bills are likely to be.

Your current rating is **band C (70)**. The average rating for EPCs in Scotland is **band D (61)**.

The potential rating shows the effect of undertaking all of the improvement measures listed within your recommendations report.

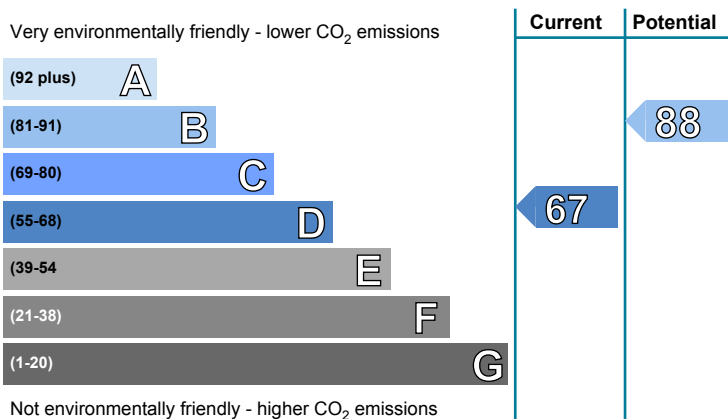
## Environmental Impact (CO<sub>2</sub>) Rating

This graph shows the effect of your home on the environment in terms of carbon dioxide (CO<sub>2</sub>) emissions. The higher the rating, the less impact it has on the environment.
